McPherson Home Inspections, LLC

Home Inspection Report

3832 Sample Drive

Inspected on Tue, Jul 11 2017 at 6:00 PM

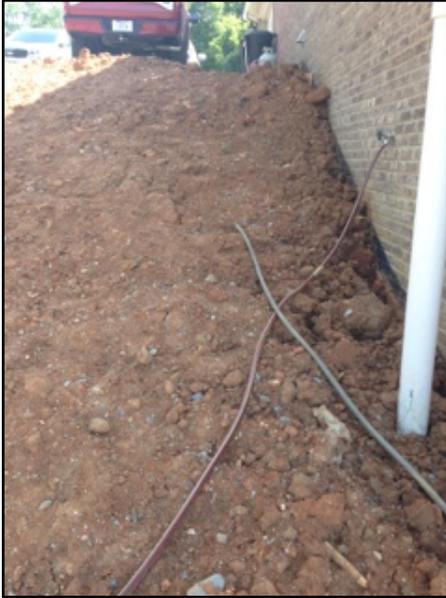
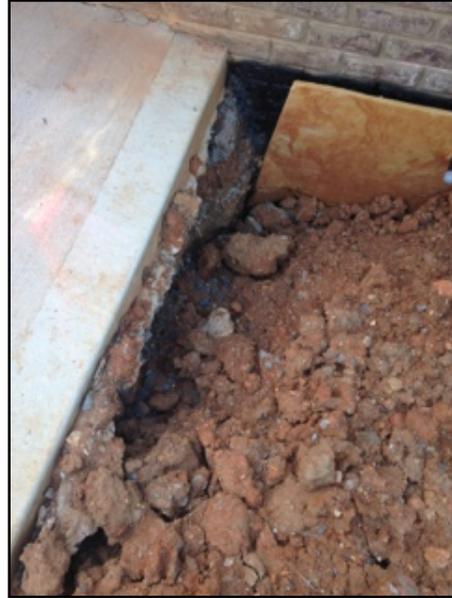
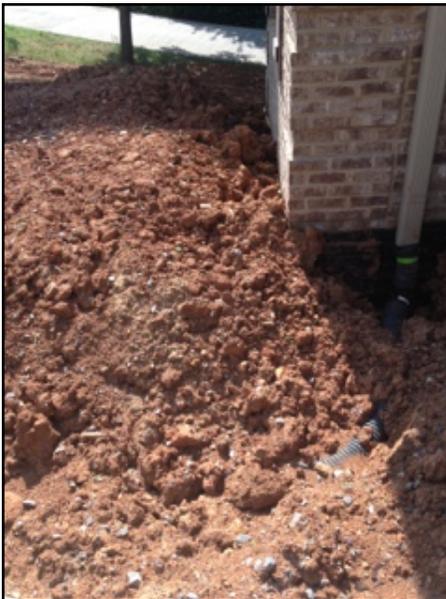
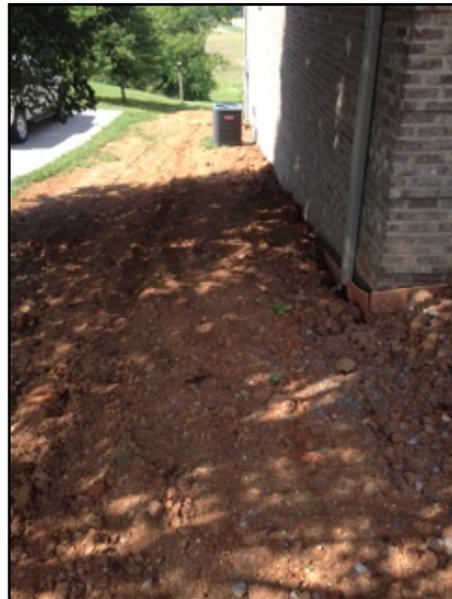
Comment 1:
Driveway shows signs of significant settling.

Comment 2:
Walkway has numerous settling cracks.

Comment 3:
Repair work was in progress so final grading could not be determined.

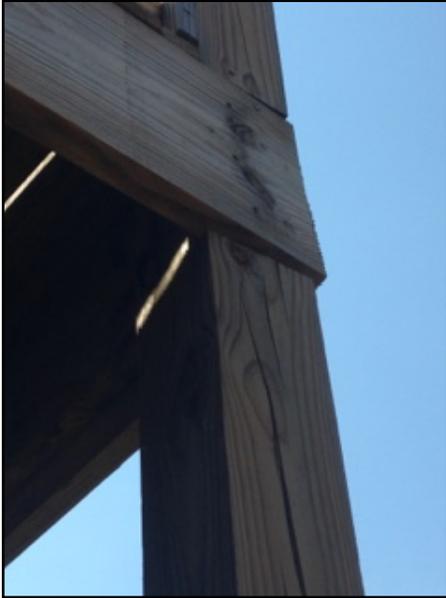
Figure 4-1

Comment 4:
Improperly connected. Lag bolts needed.

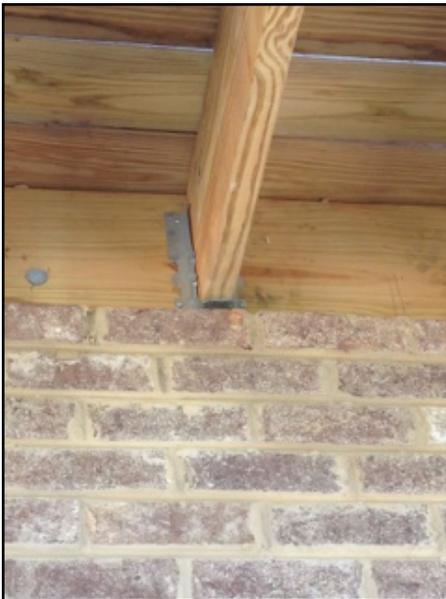
Figure 5-1

Comment 5:
Deck is missing flashing.

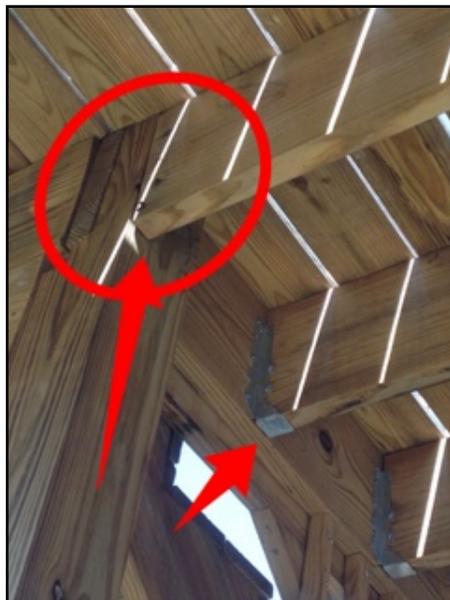
Figure 6-1

Floor joist improperly attached. Toe nailed in rather than properly seated or hung with joist hangers.

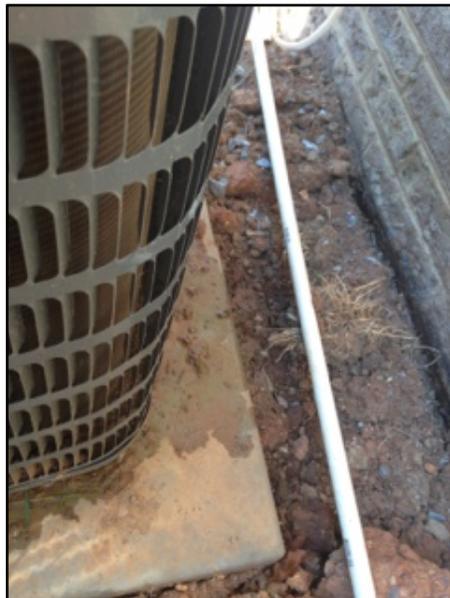
Figure 8-1

Comment 8:
Not drained away from foundation.

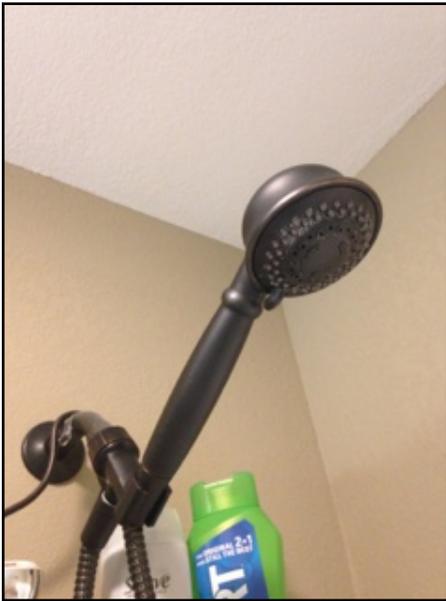
Figure 9-1

Comment 9:
Shower head leaks.

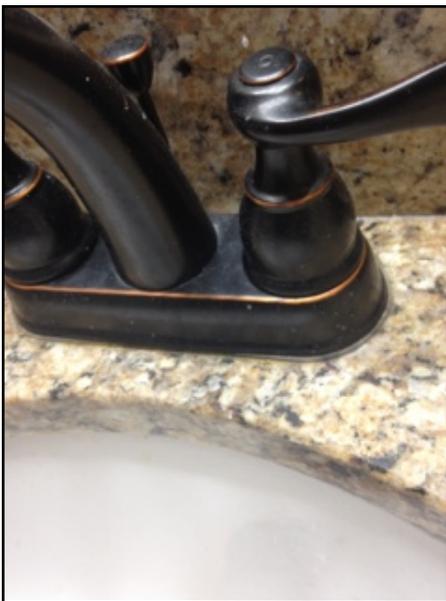
Figure 10-1

Comment 10:
Faucet leaks at base.

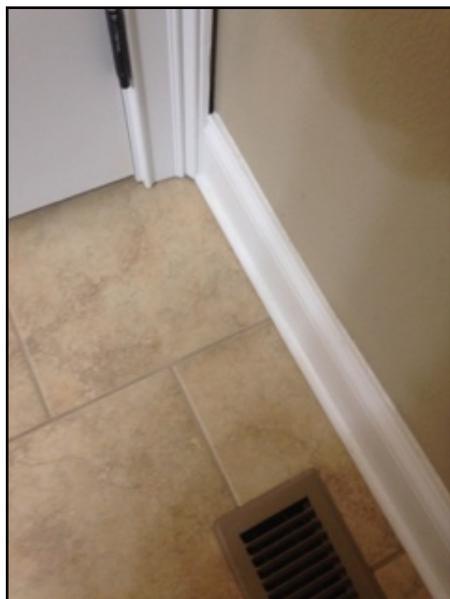
Figure 11-1

Comment 11:
Seal along baseboards.

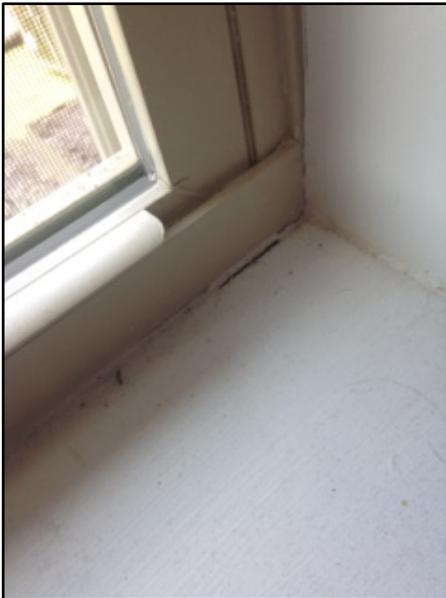
Figure 15-1

Comment 15:
Caulk around windows.

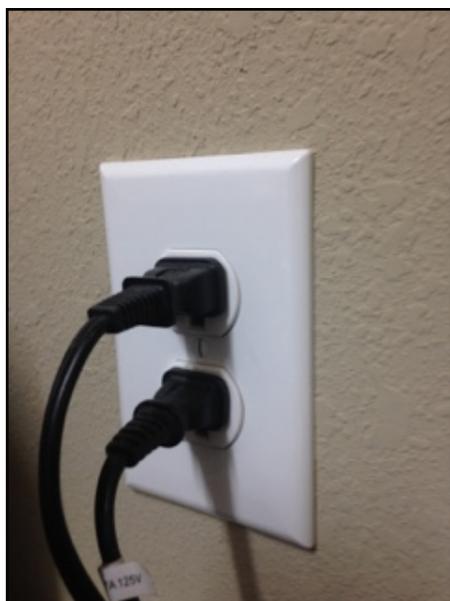
Figure 16-1

Comment 16:
Not GFCI protected.

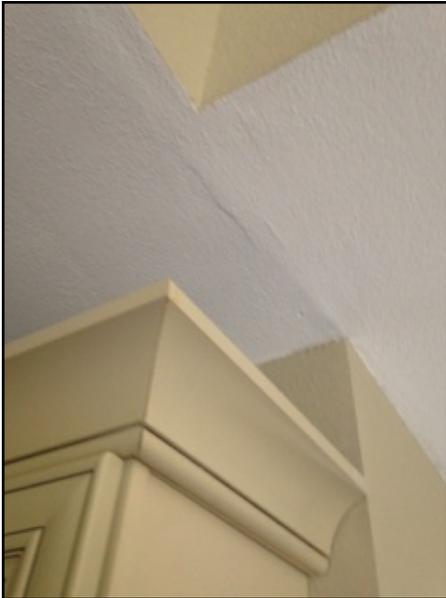
Figure 17-1

Comment 17:
Evidence of previous repair in kitchen.

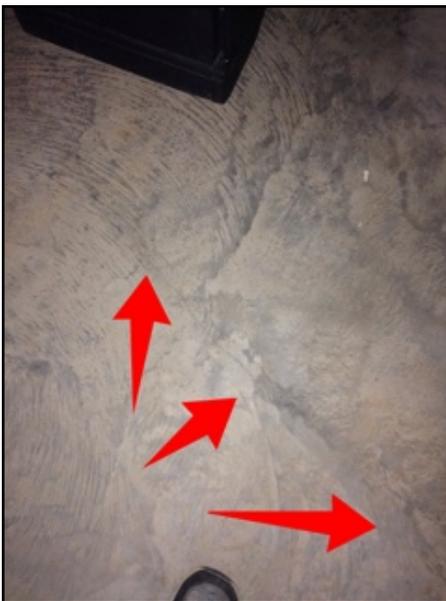
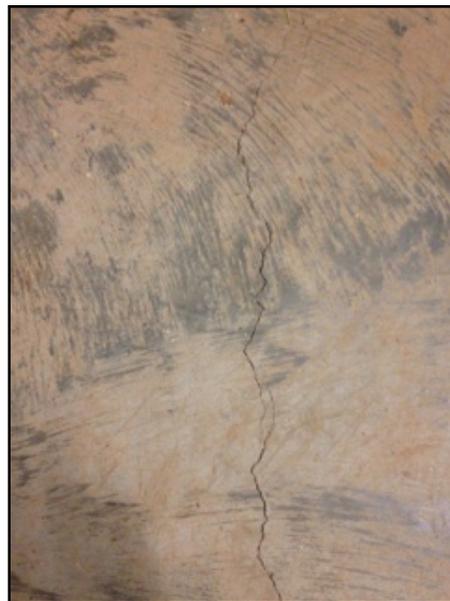
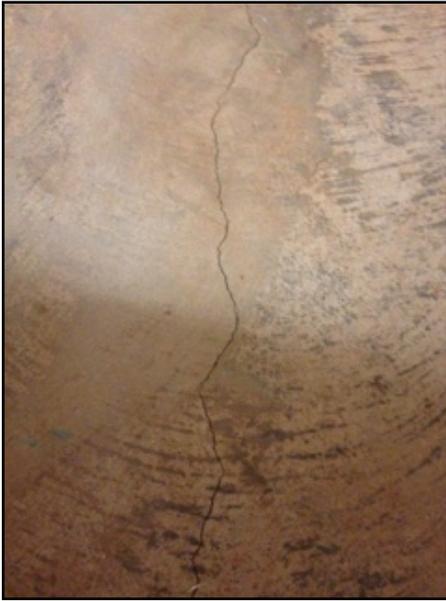
Comment 19:
Settling crack in slab.

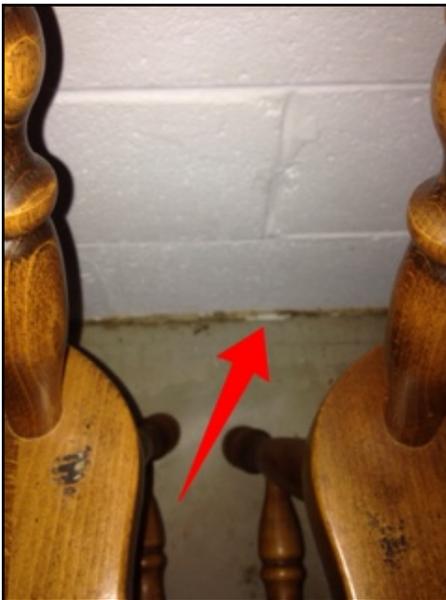
Figure 20-1

Comment 20:
Indication of moisture intrusion.

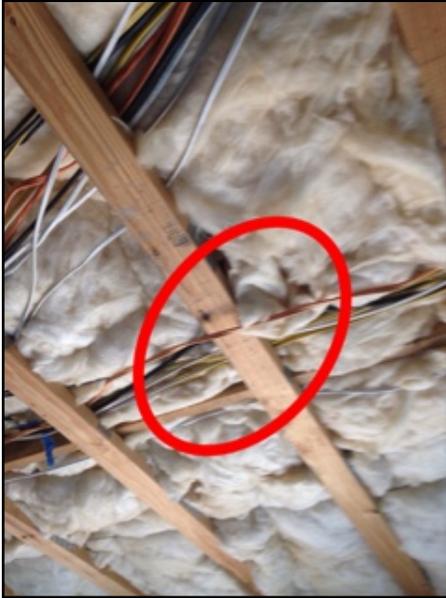
Figure 21-1

Comment 21:
Electrical wire looped under ceiling joist.

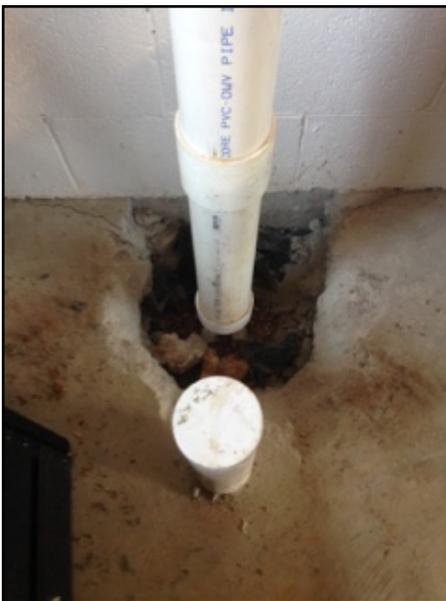
Figure 22-1

Comment 22:
Open hole in slab.

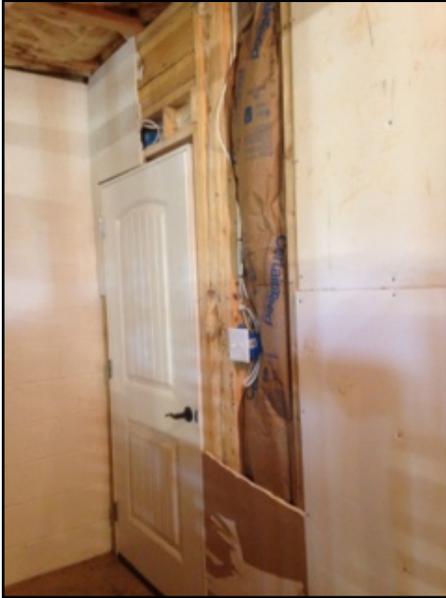
Figure 23-1

Comment 23:
Drywall damaged.

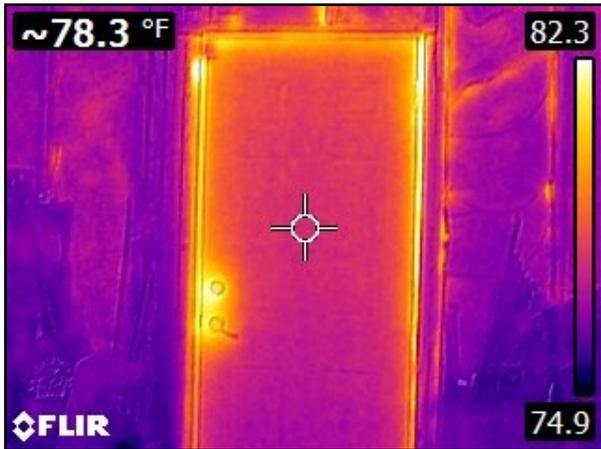
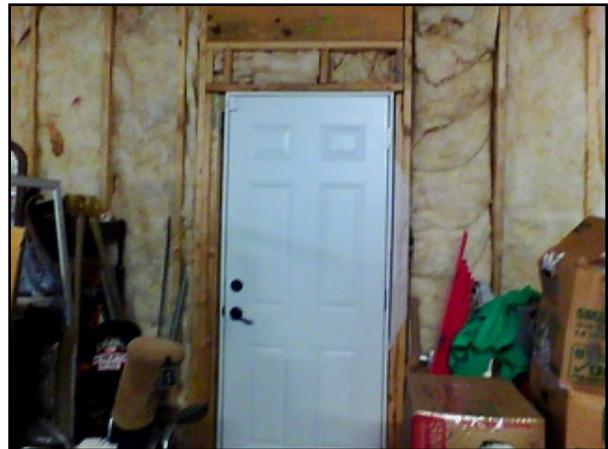
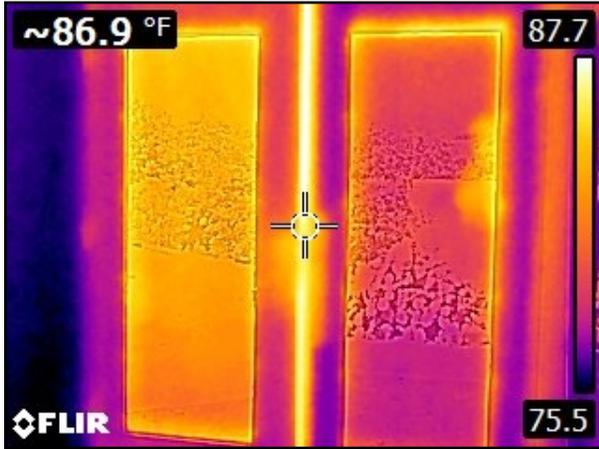
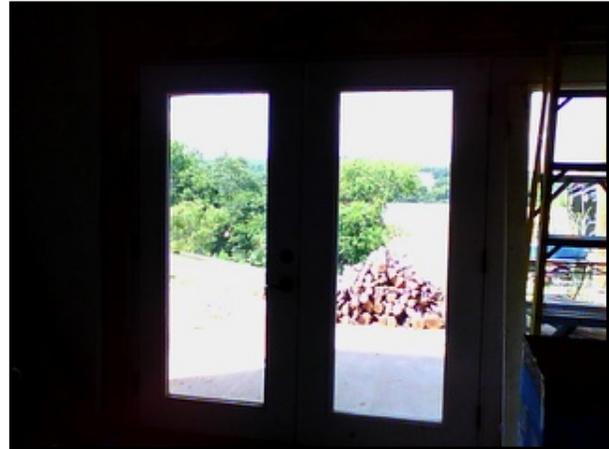
Comment 24:
Energy loss around doors. Check seals and caulking.

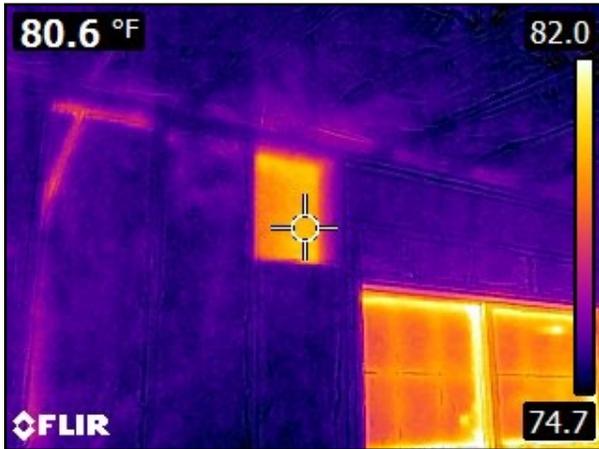
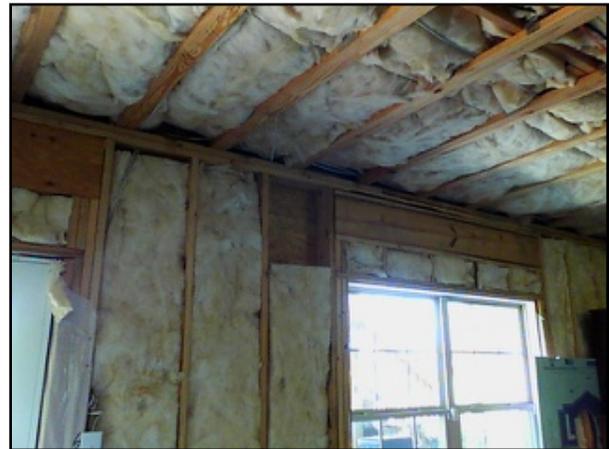
Missing insulation. Repair or replace missing insulation.

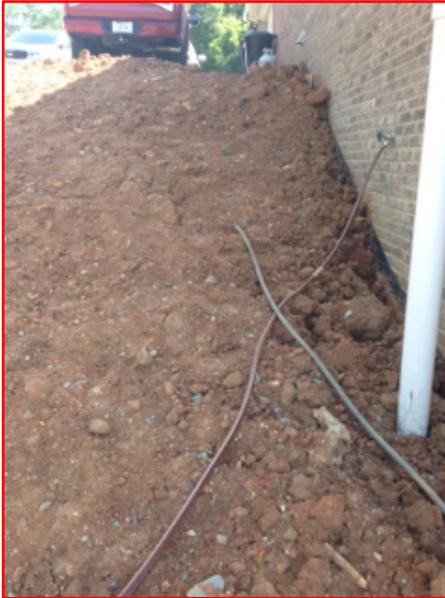
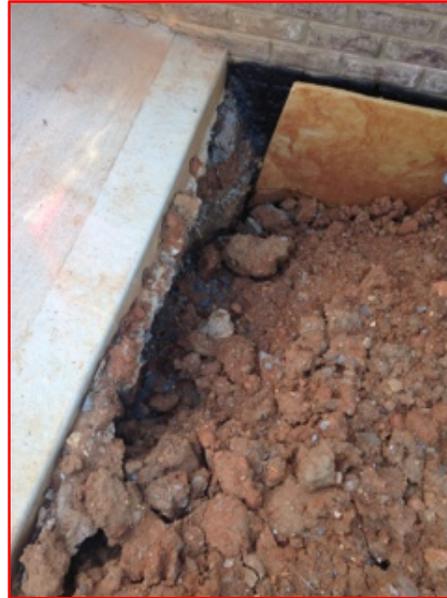
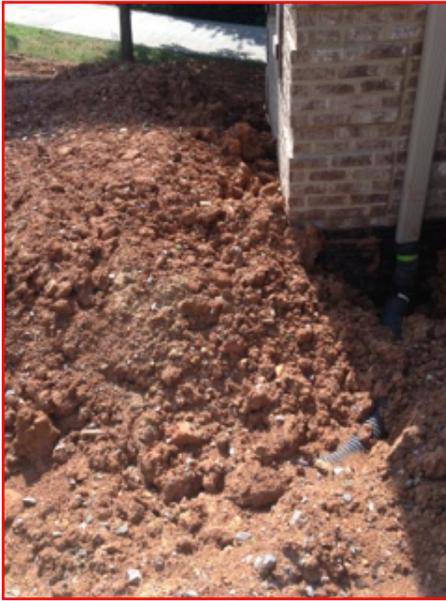
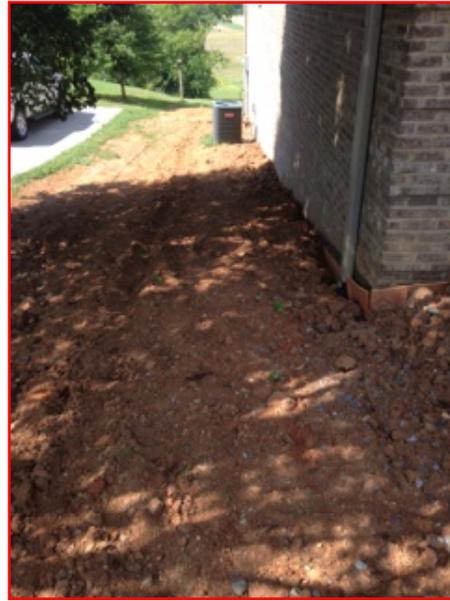
- 1) Driveway shows signs of significant settling.
- 2) Walkway has numerous settling cracks.
- 3) Repair work was in progress so final grading could not be determined.

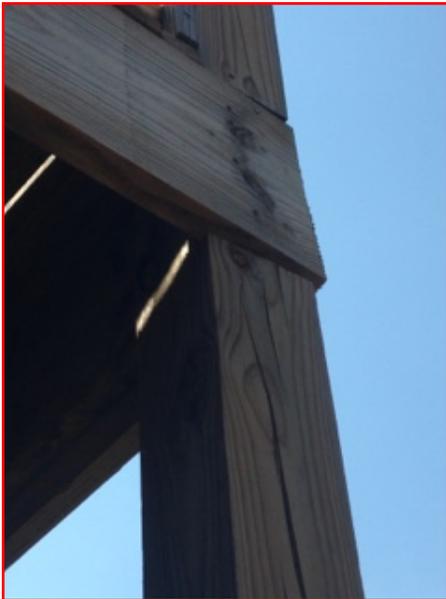
Figure 4-1

4) Improperly connected. Lag bolts needed.

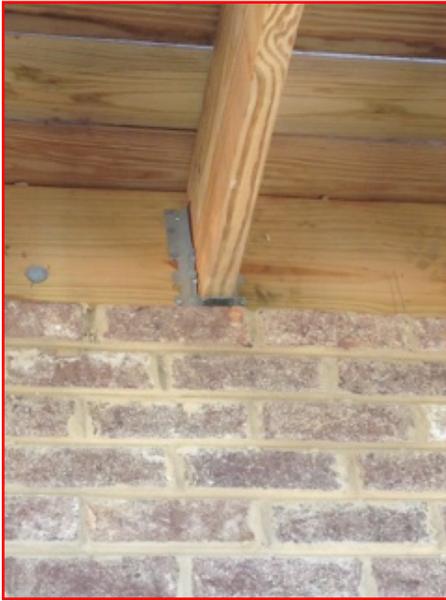
Figure 5-1

5) Deck is missing flashing.

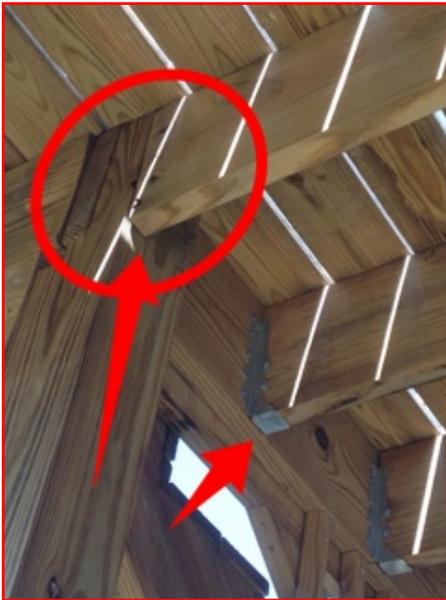
Figure 6-1

6) Floor joist improperly attached. Toe nailed in rather than properly seated or hung with joist hangers.

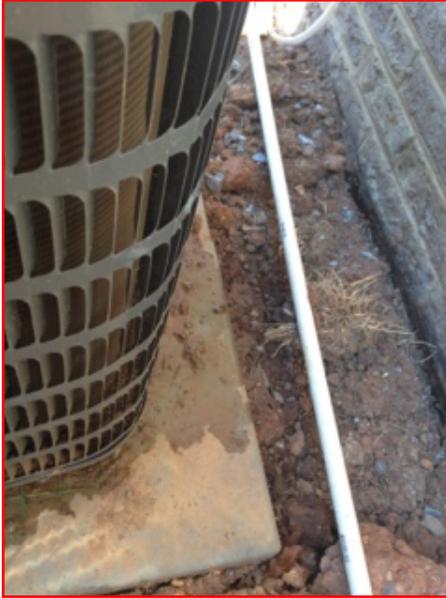
Figure 8-1

8) Not drained away from foundation.

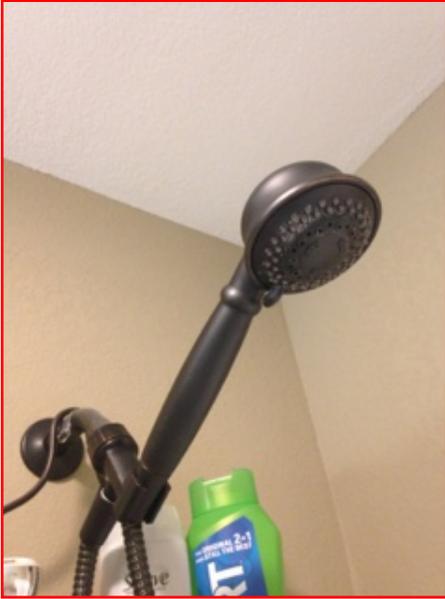
Figure 9-1

9) Shower head leaks.

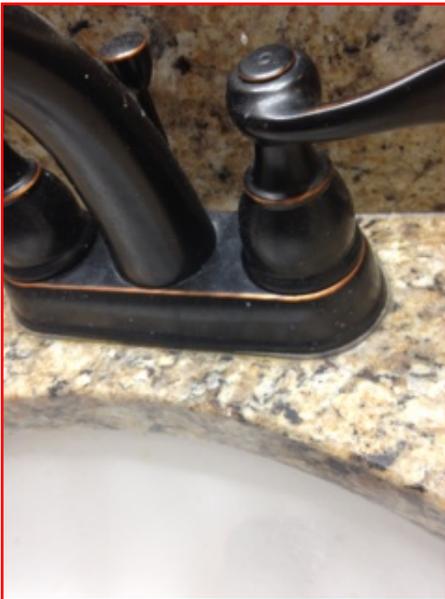
Figure 10-1

10) Faucet leaks at base.

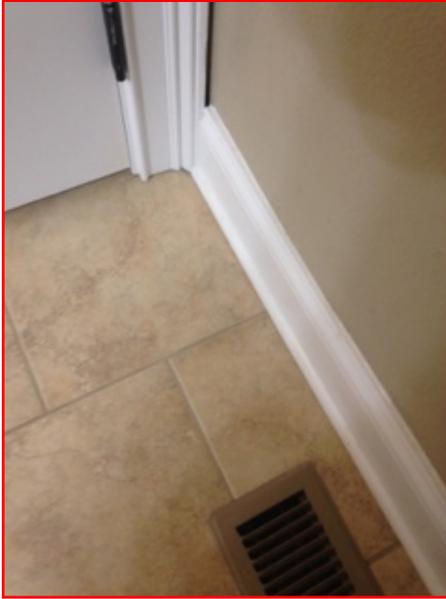
Figure 11-1

11) Seal along baseboards.

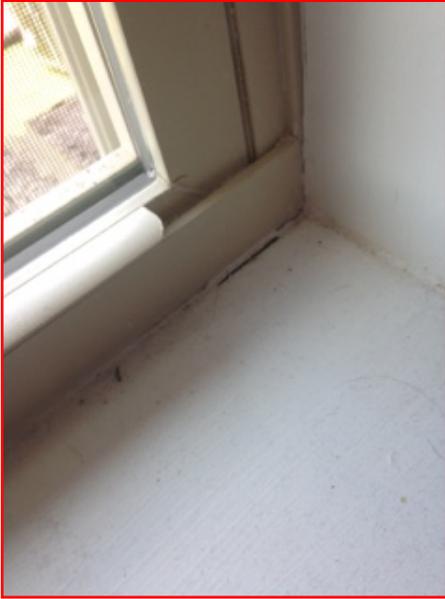
Figure 15-1

15) Caulk around windows.

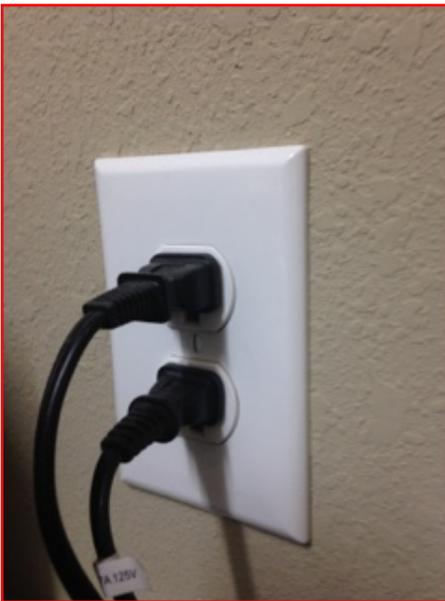
Figure 16-1

16) Not GFCI protected.

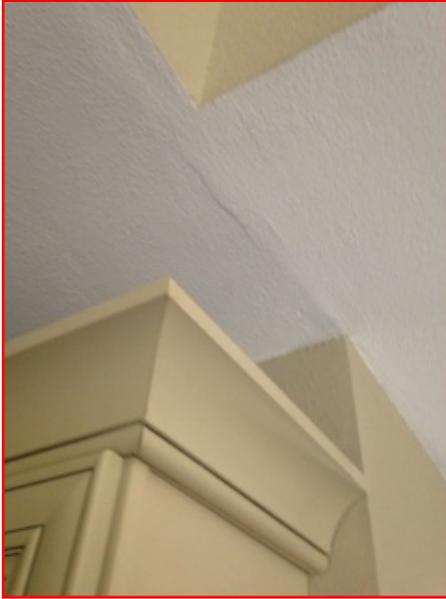
Figure 17-1

17) Evidence of previous repair in kitchen.

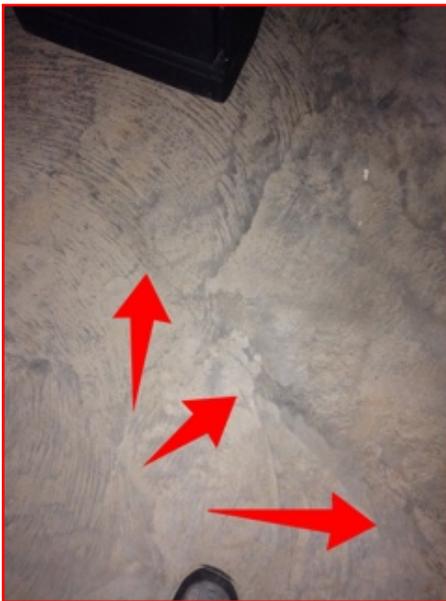
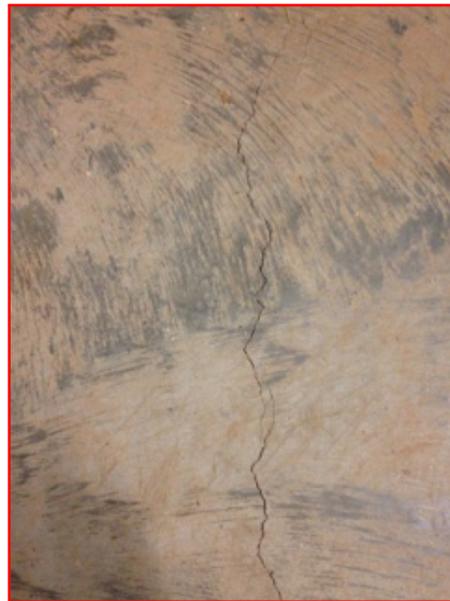
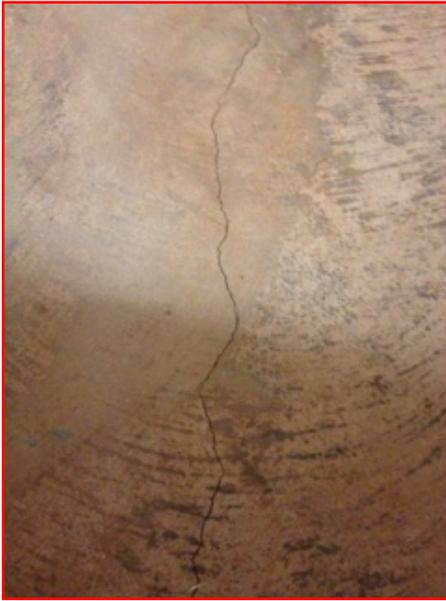
18) Settling crack in slab.

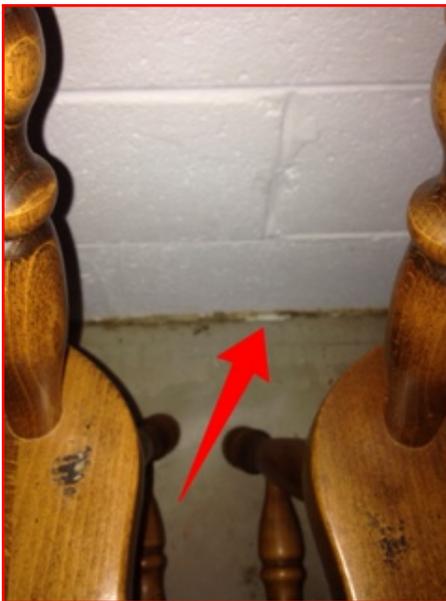
Figure 20-1

19) Indication of moisture intrusion.

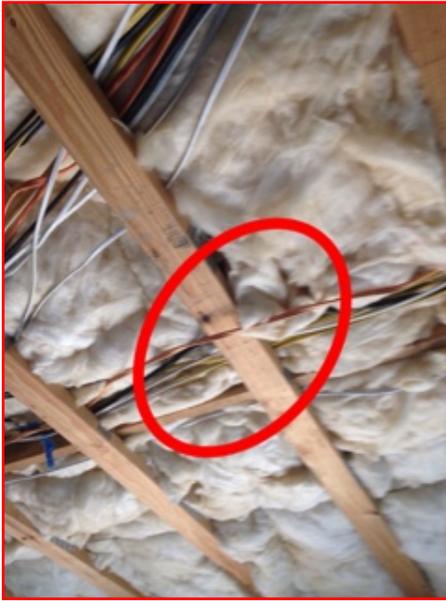
Figure 21-1

20) Electrical wire looped under ceiling joist.

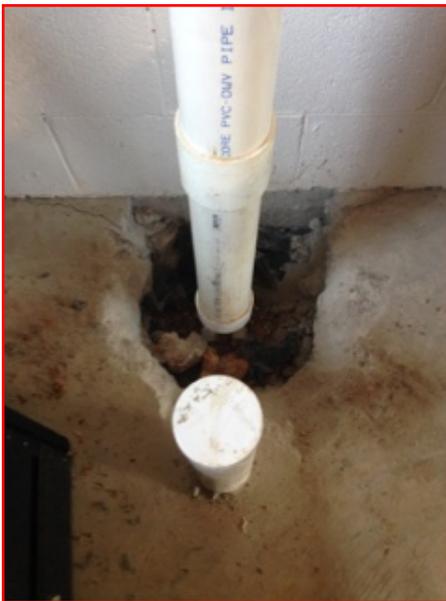
Figure 22-1

21) Open hole in slab.

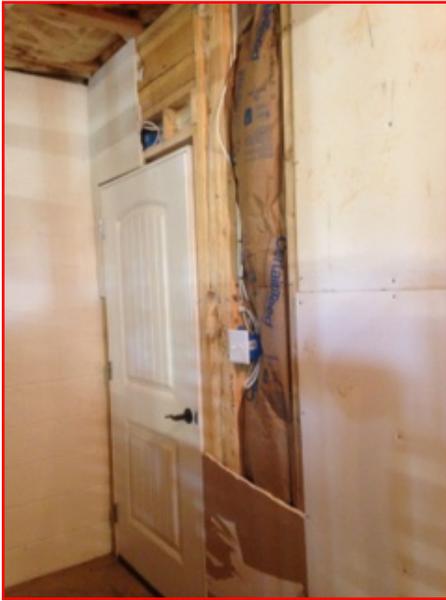
Figure 23-1

22) Drywall damaged.

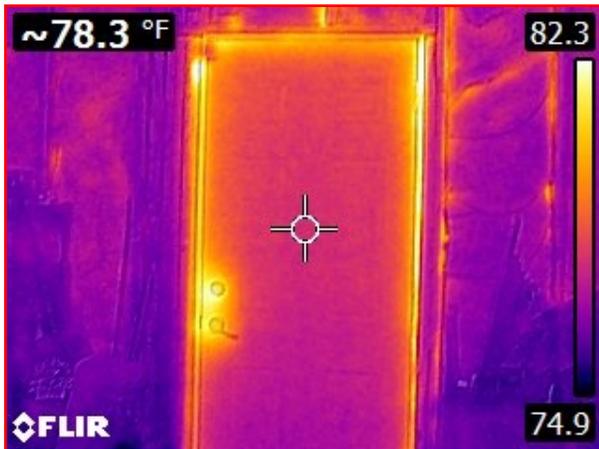
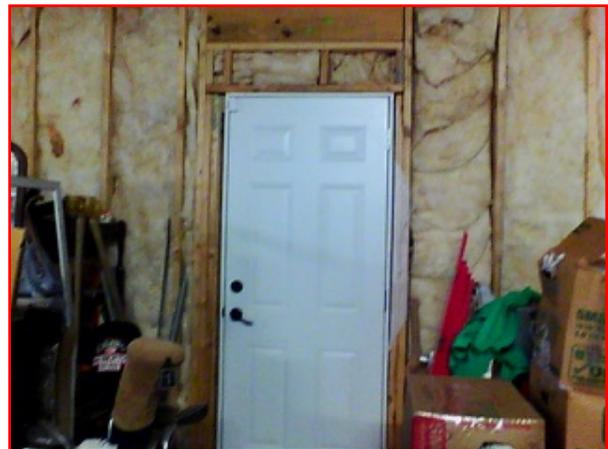
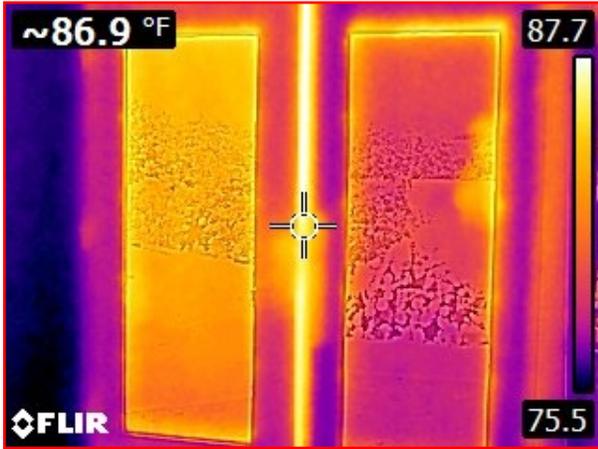
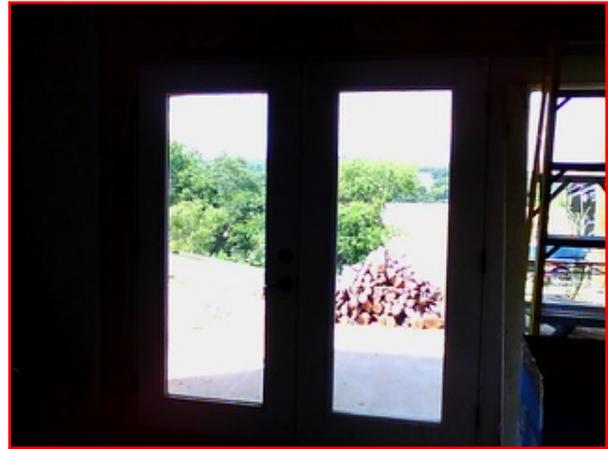
23) Energy loss around doors. Check seals and caulking.

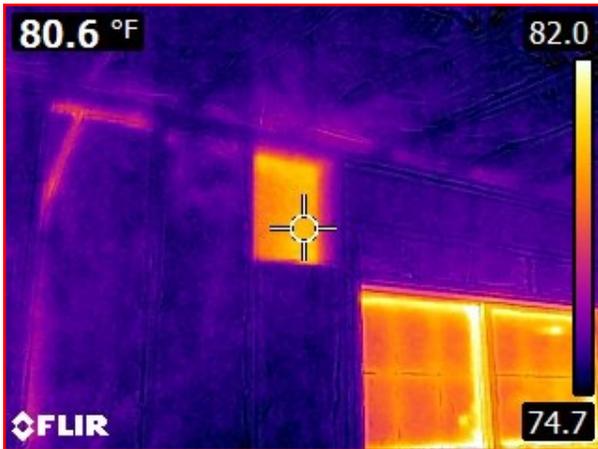
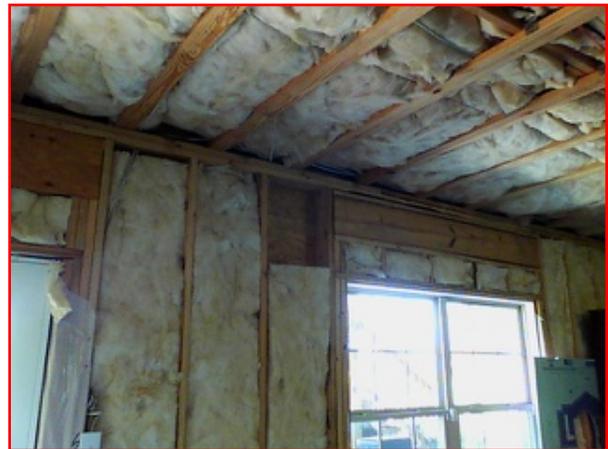
24) Missing insulation. Repair or replace missing insulation.
